# Care, Maintenance, and Troubleshooting of HPLC Columns

## Part 2

# Major Areas of Column Problems - Dramatic Changes in 3 Key Areas:

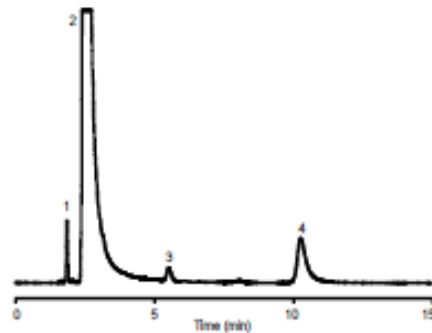
Injection 1

## Split Peaks Column Contamination

Column: StableBond SB-C8, 4.6 x 150 mm, 5  $\mu$ m      Mobile Phase: 60% 25 mM  $\text{Na}_2\text{HPO}_4$ , pH 3.0 : 40% MeOH      Flow Rate: 1.0 mL/min  
Temperature: 35°C      Detection: UV 254 nm      Sample: Filtered OTC Cold Medication: 1. Pseudoephedrine      2. APAP      3. Unknown      4. Chlorpheniramine

- Column washing eliminates the peak splitting, which resulted from a contaminant on the column.

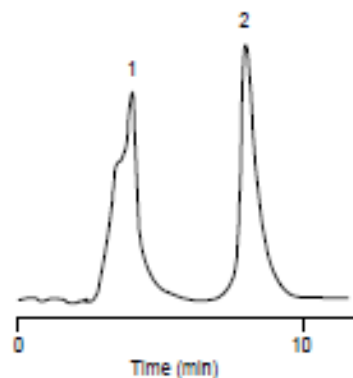
Column: StableBond SB-C8, 4.6 x 150 mm, 5  $\mu$ m

Mobile Phase: 82% H<sub>2</sub>O : 18% ACN

Injection Volume: 30  $\mu$ L

Sample: 1. Caffeine 2. Salicylamide

**A. Injection Solvent  
100% Acetonitrile**

- Injecting in a solvent stronger than the mobile phase can cause peak shape problems, such as peak splitting or broadening.
- Note: earlier peaks (low k) most affected

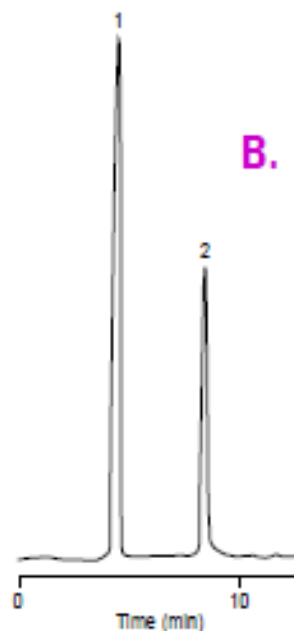
**B. Injection Solvent  
Mobile Phase**

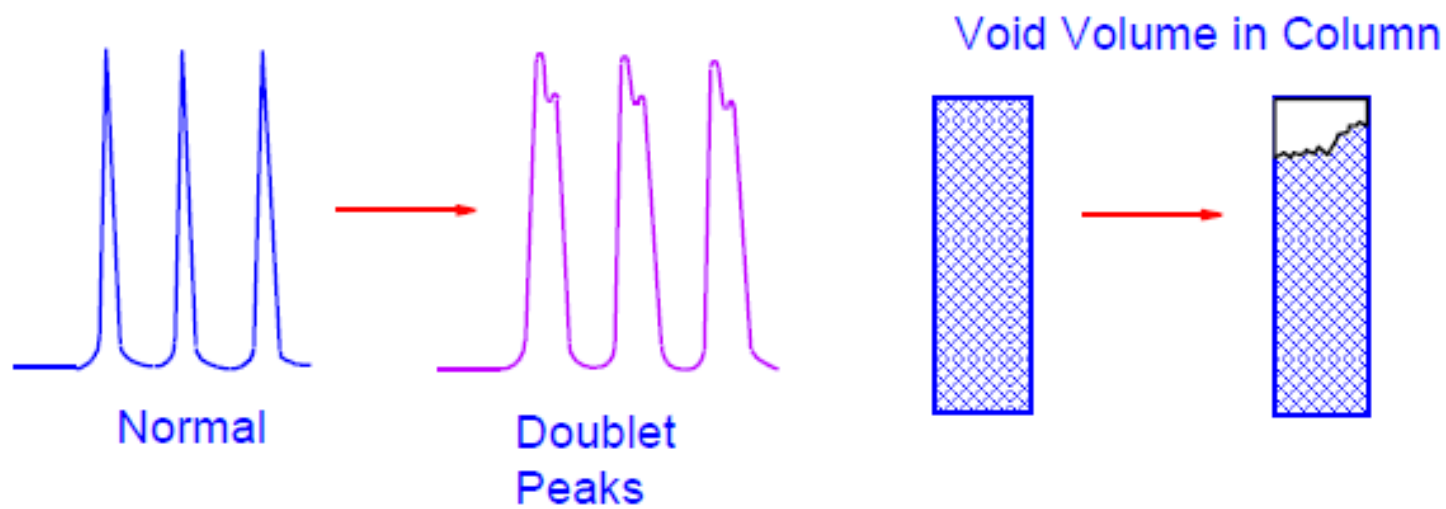
# Peak Shape Problems - Doublets

- Void Volume in Column
- Partially Blocked Frit

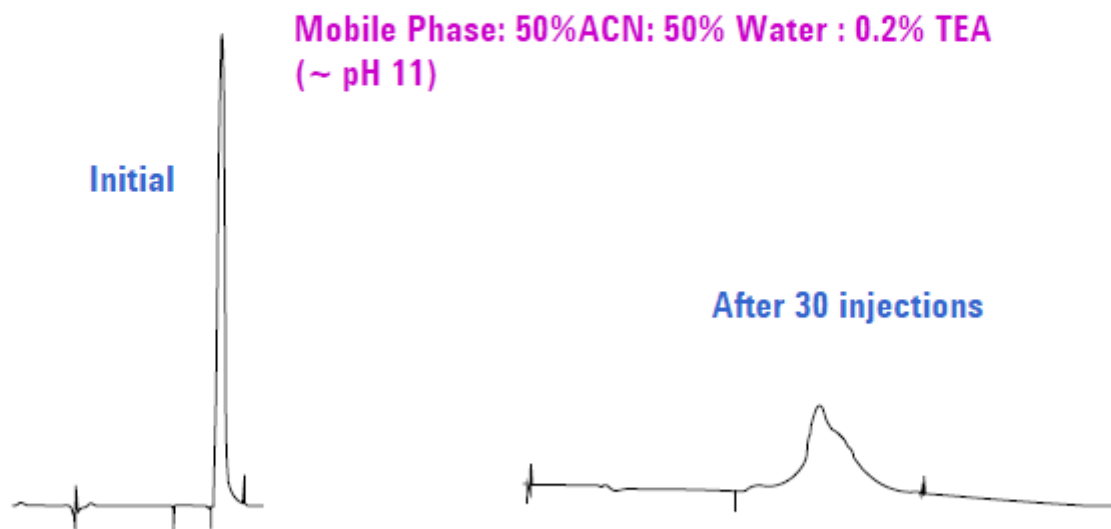
## Peak Broadening, Splitting Column Void

- Multiple peak shape changes can be caused by the same column problem. In this case a void resulted from silica dissolved at high pH.
